# Manhole Inspection Summary

Manhole # S31M\_\_003MH

**Inspection** ☐ Is Incomplete Rating: **3) Fair**

**Location** Address: **612 Warner St**

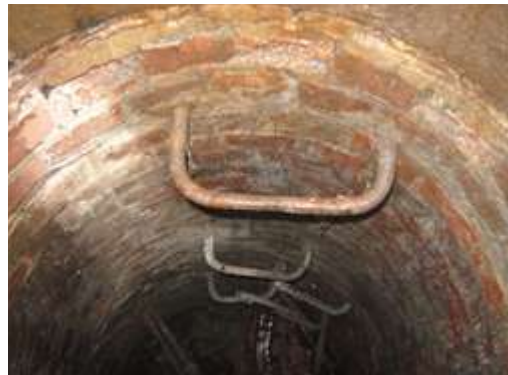
Defect 6

Count: **6** Missing: **1** ☒ **Corroded**

steps corroded

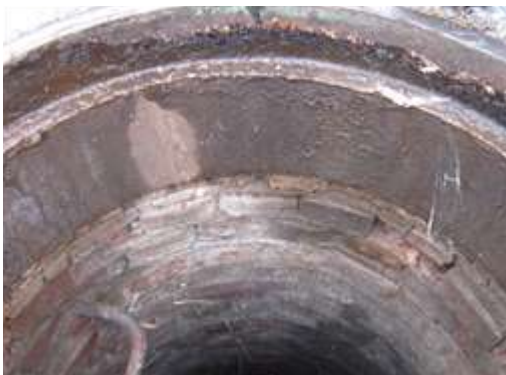
Defect 5

Condition: ☐ Sound ☐ Cracked ☒ **Leaks**

frame infiltration at lid

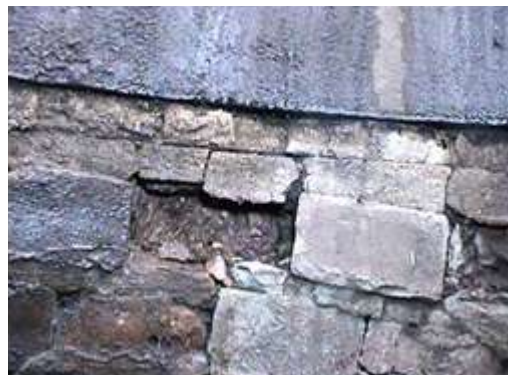
Defect 4

Condition: ☐ Sound ☒ **Cracked** ☐ Root Intrusion ☒ **Loose Brick** ☐ Deteriorated

Infiltration: ☐ None ☒ **Joint** ☐ Cracks ☐ Mortar ☐ Roots ☒ **Wall**

chimney craked loose bricks and infiltration at wall

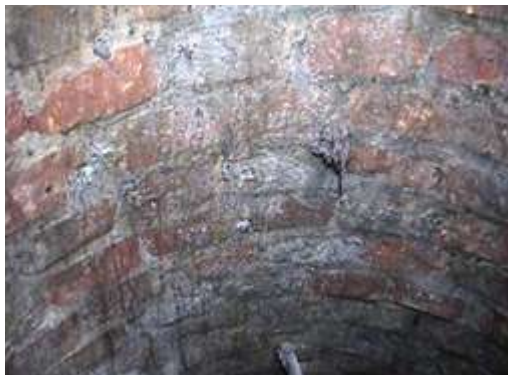
Defect 3

step missing

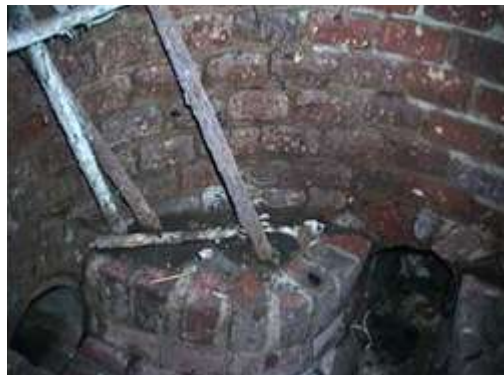
Defect 1

Condition: ☐ Sound ☐ Cracked ☐ Root Intrusion ☐ Deteriorated ☐ Leaks ☒ **Debris**

bench debris near 12 OClock

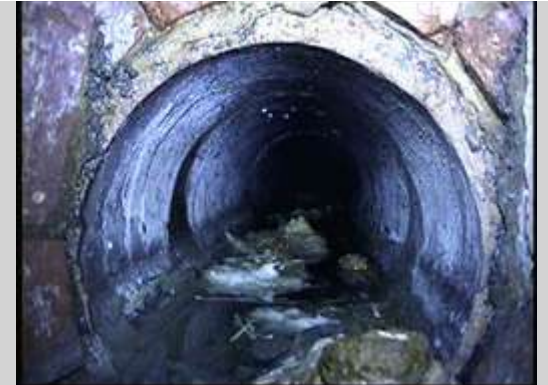
12 O'Clock Outflow

Pipe Height: **8.4** (in.) Rod and Bar (Angled)  
Pipe Material: **Clay** ☐ Pipe Lined  
Invert Depth: **10.76** (ft.) Flow Characteristics: **None**  
Deposits: ☒ None ☐ Mud ☐ Sludge ☐ Debris ☐ Grease  
Silt Depth: **0** (in.) Deposits Extent:  
Infiltration: **None** Pipe Seal Cond: **Sound**

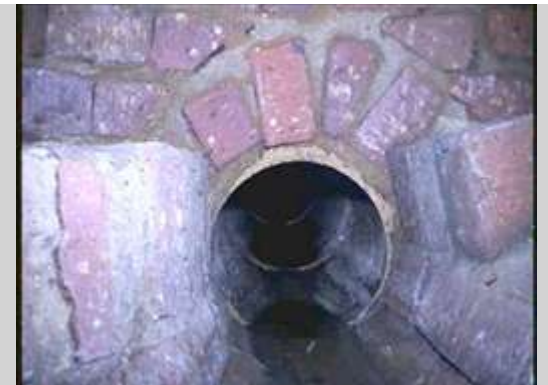
3 O'Clock Inflow

Pipe Height: **8.4** (in.) Rod and Bar (Angled)  
Pipe Material: **Clay** ☐ Pipe Lined  
Invert Depth: **10.68** (ft.) Flow Characteristics: **None**  
Deposits: ☒ None ☐ Mud ☐ Sludge ☐ Debris ☐ Grease  
Silt Depth: **0** (in.) Deposits Extent:  
Infiltration: **None** Pipe Seal Cond: **Sound**

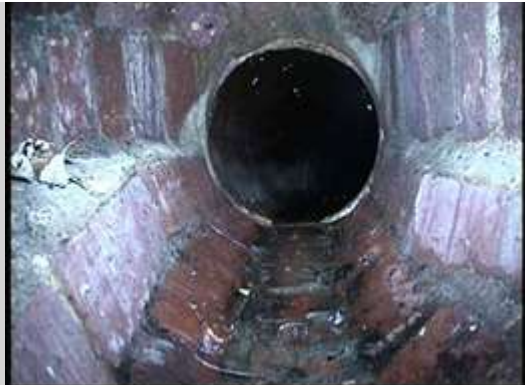
5 O'Clock Inflow

Infiltration: **None** Pipe Seal Cond: **Sound**

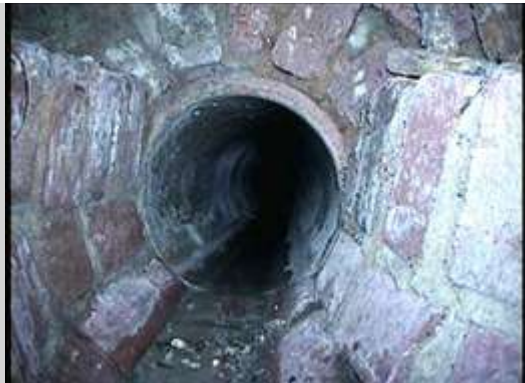
8 O'Clock Inflow

Infiltration: **None** Pipe Seal Cond: **Sound**
